FRANKLIN HIGH SCHOOL FACILITY ASSESSMENT

MACON COUNTY SCHOOLS

JUNE 2022

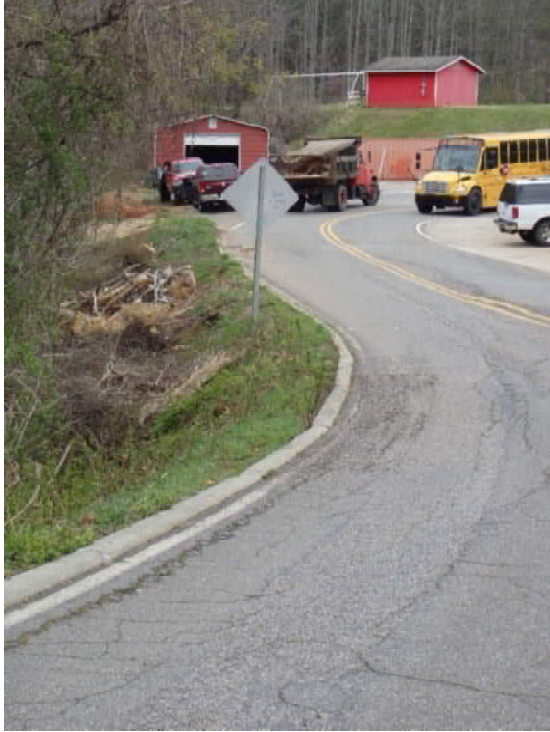
Fig. 1: Subsiding pavement at McCollum Drive

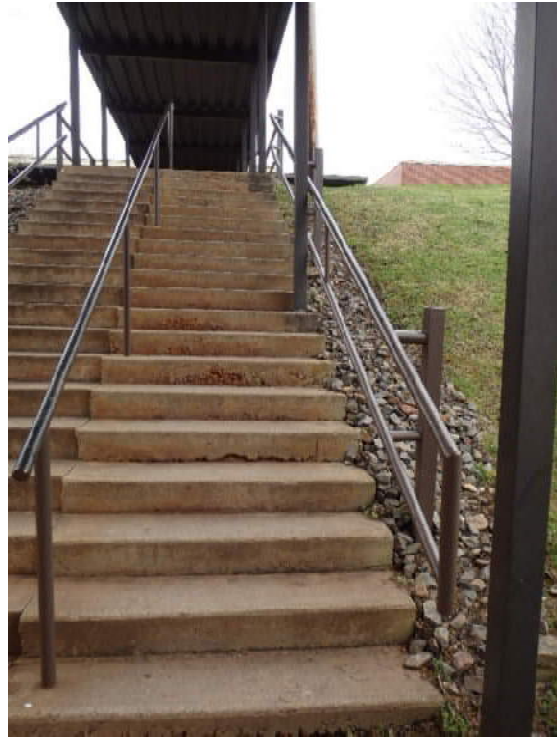
Fig. 7: Deteriorated stair

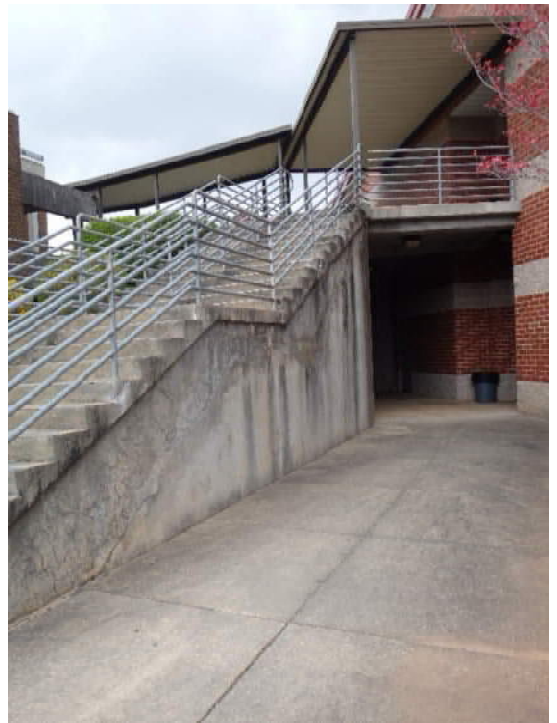
Fig. 8: Deteriorated stairs.

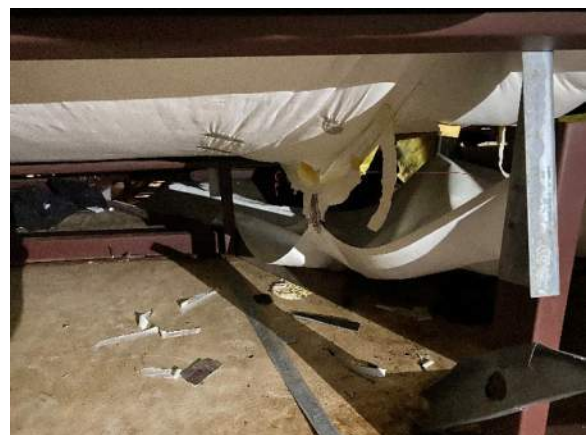
Fig. 2: Collecting roof leaks, Main Building

- Steps at the main entry are uneven and settling. *Replacement is needed.*
- A retrofit overbuild superstructure and metal roofing system (see figures 1 & 2) was installed in 2000 directly on top of a failed single ply membrane roof. This overbuild superstructure appears to bear on top of the insulation and previous roofing system and is subject to movement from wind and gravity loads if any compression of that system occurs. The roof and gutters are a source of chronic leaks, particularly at the roof hips. *Roof replacement is required.*

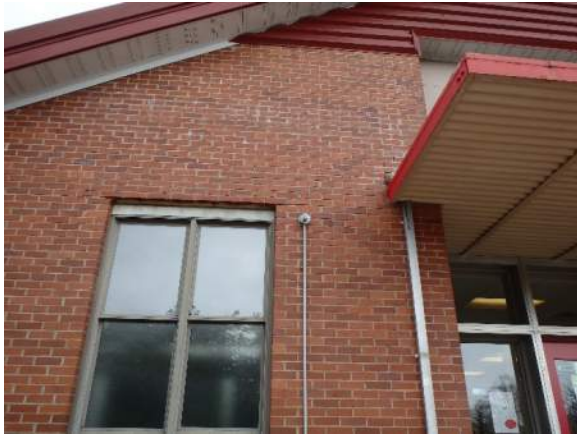
- Settlement cracking at the main entry facade and numerous window heads was repaired during the 1986 renovations. Those cracks have re-emerged in places and require repairs (see figure 3). *Repair is required.*

- Windows were replaced in 1986. The balances have broken, rendering most of the double-hung sashes inoperable, and the seals on the double pane insulated glass in those units have failed, causing condensation between the panes (See figure 3). *Replacement is required.*

- *Selective steel lintel replacement is required* at locations with extensive rust (See figure 3).

Fig. 3: Condensation in glass, rusted lintel, diagonal cracking at window head

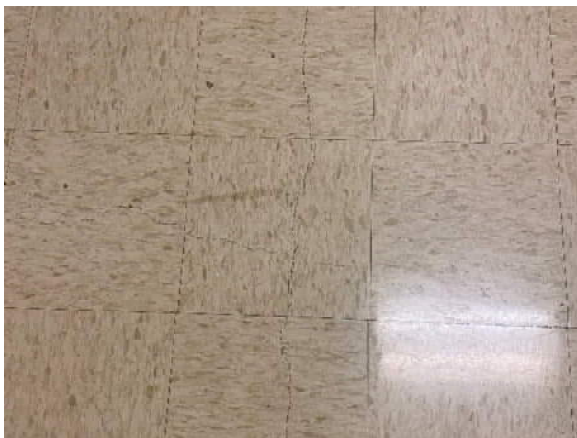
Fig 5: Cracking in corridor floor slabs

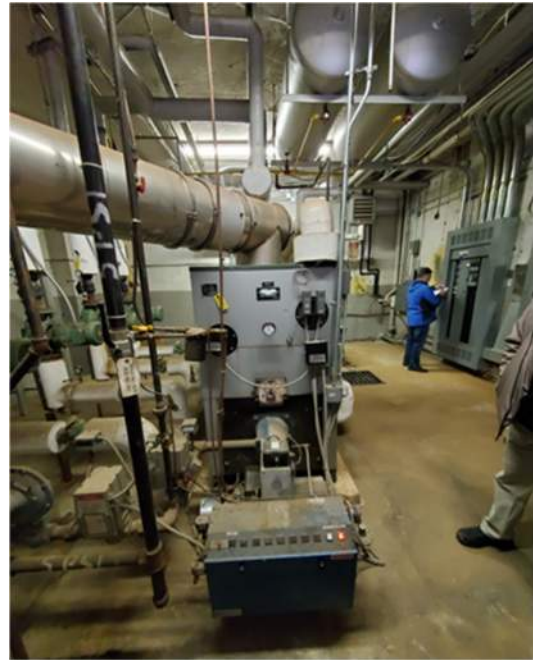
- The boiler is a Peerless Cast Iron boiler and is located in the basement (see figure 7). This boiler has been replaced since the building was built, but it was discussed that this unit has reached the end of its service life. The ASHRAE Equipment Life Expectancy for this style boiler is 30 years.

Fig. 7: Boiler

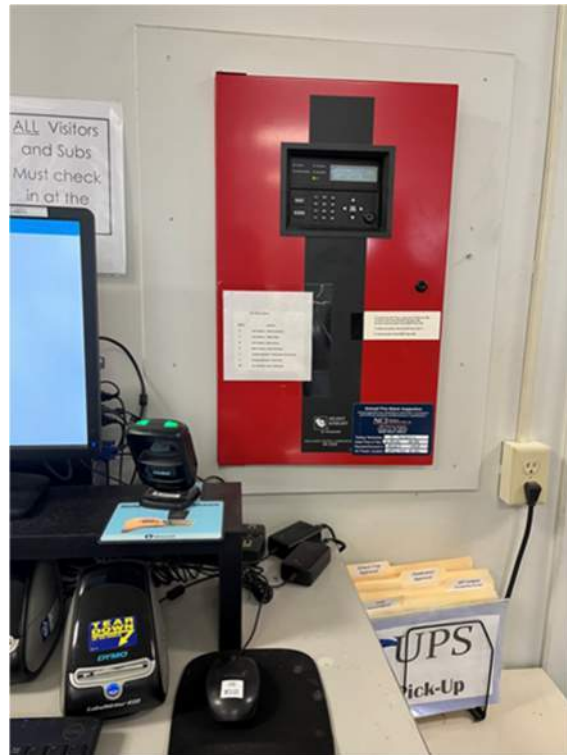
Fig. 11: Existing fire alarm

Each building on campus is currently served by independent non-addressable fire alarm systems. These are local alarms with no building-to-building connections. The entire system should be replaced with a new fully addressable system with Voice Evacuation capabilities to comply with current life safety codes.

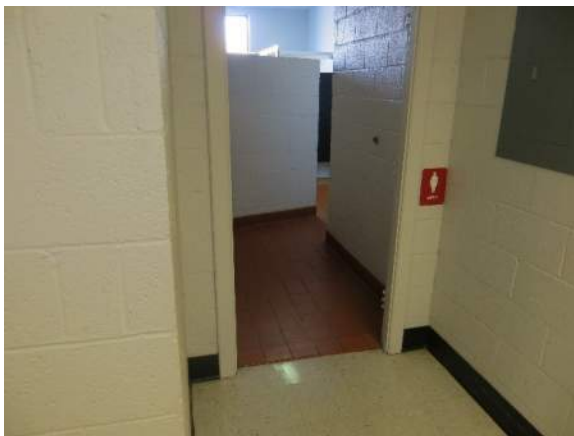
Fig. 14: Inadequate clearance, restroom entry

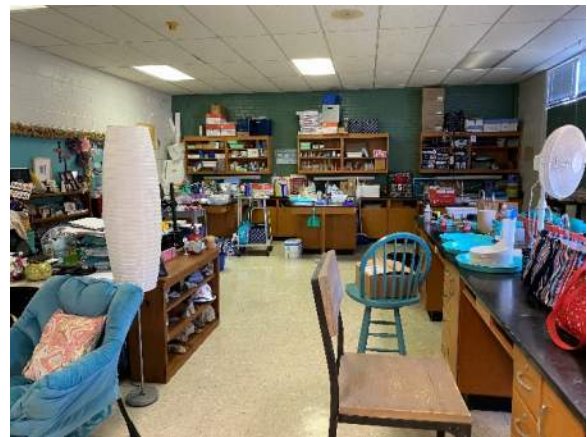
Fig. 17: Critically undersized science room.

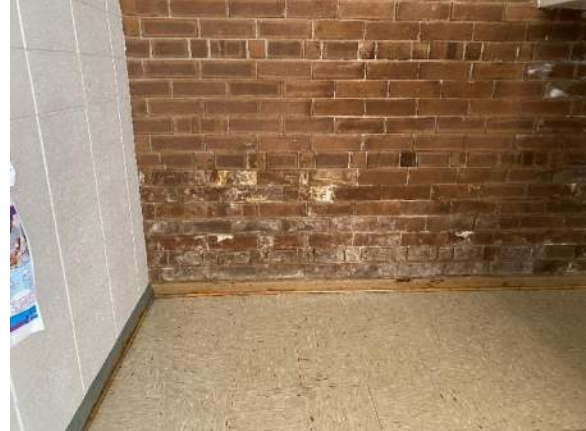
Fig 4: Moisture damage at interior walls

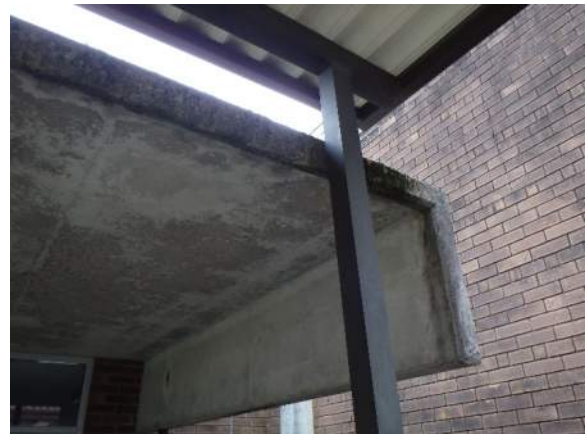
Fig. 5: Deteriorated concrete canopy

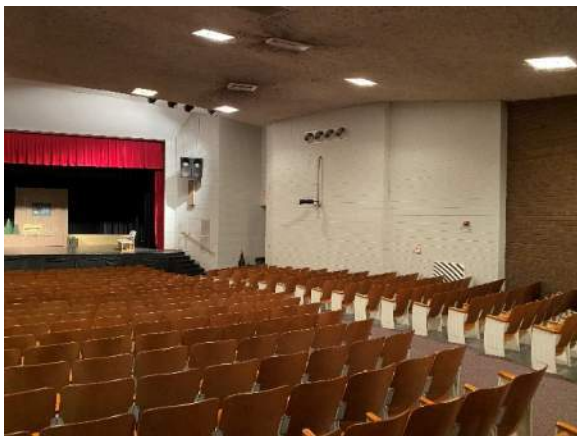
Fig. 3: Small auditorium, inaccessible stage

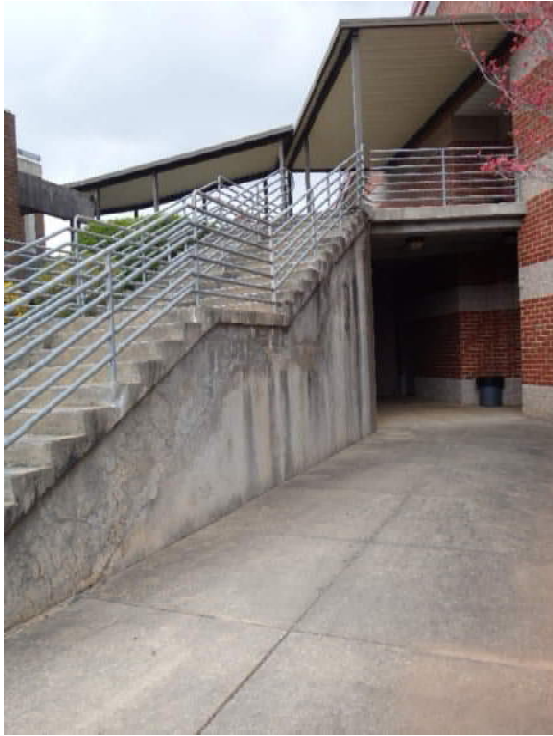
Fig. 1: Deteriorating stair, concealed entry.

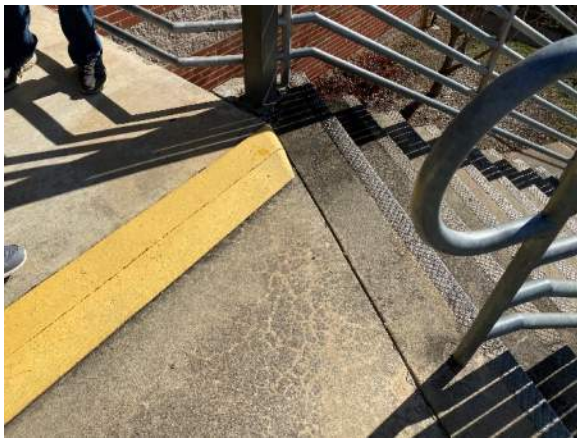
Fig. 2: Subsidence at walkway beside entry

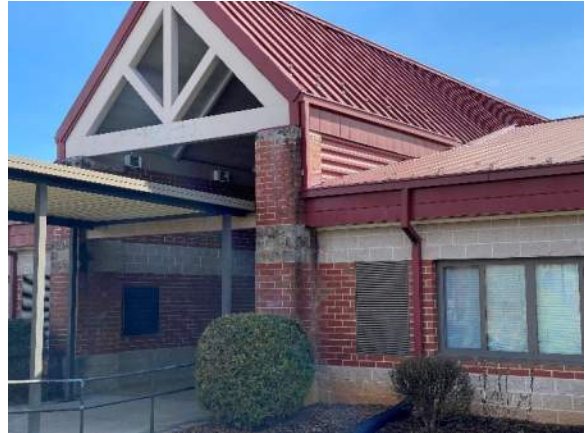
Fig. 3: Area of roof leaks, pilaster damage beside breezeway roof.

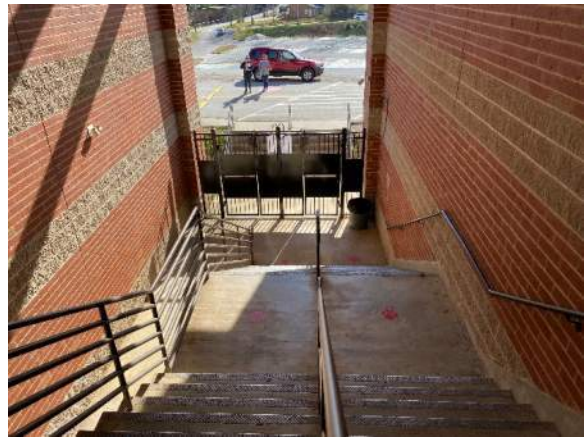
Fig. 4: Breezeway to nowhere.

- Infill of the breezeway and elimination of the open stairway there can provide additional classroom space and eliminate a non-secure campus access point.

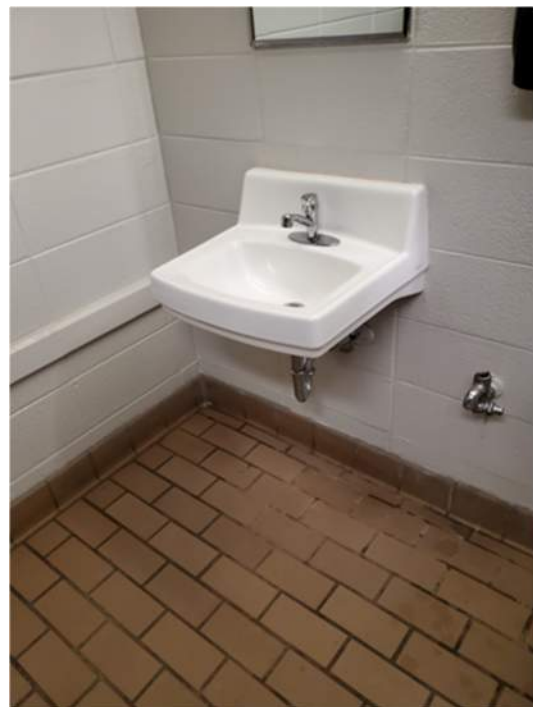
Fig. 4: Restroom fixture, stained mortar

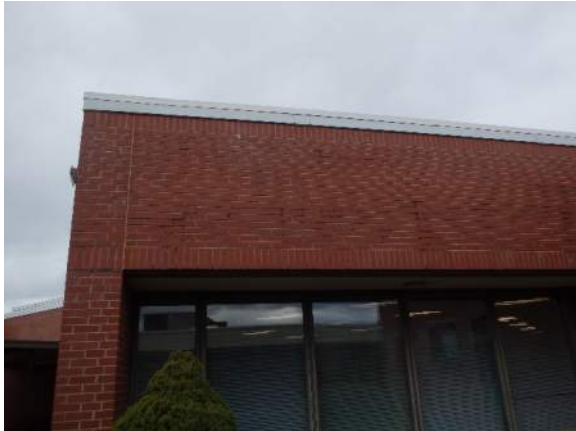
Fig. 1: Extensive moisture damage at grout joints.

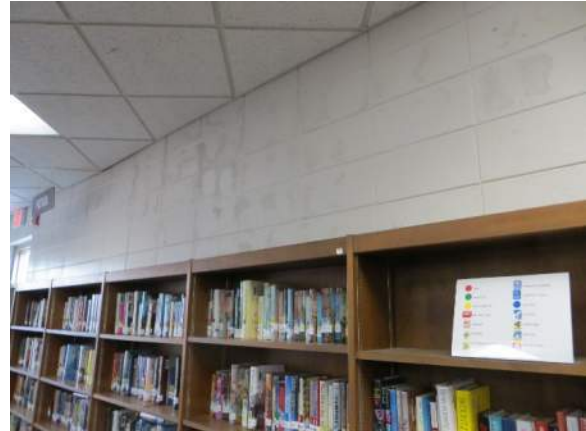
Fig. 4: Moisture infiltration at exterior walls.

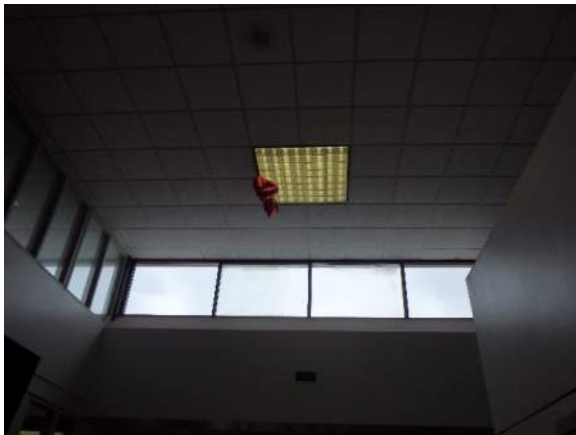
Fig. 2: Broken seals at leaky clerestory windows.

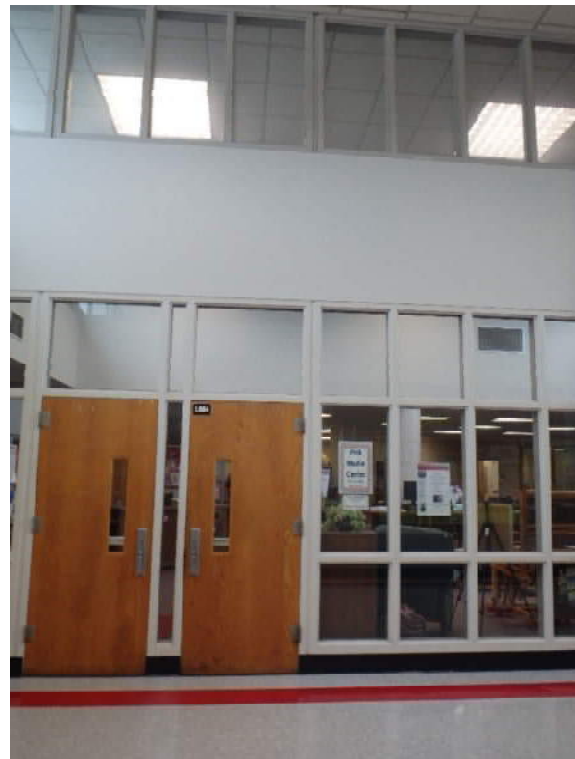
Fig. 5: Wire glass at lobby windows.

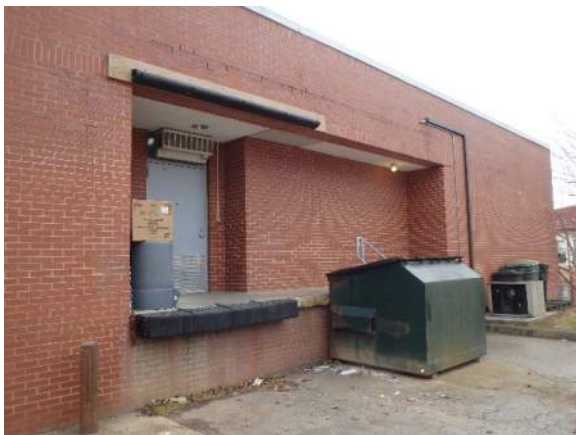
Fig. 3: Damage at loading dock; inadequate maneuvering space for trucks.

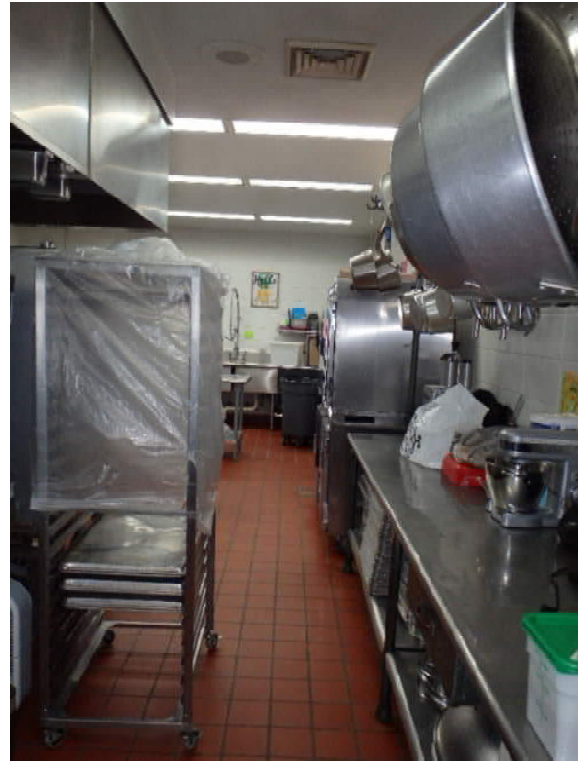
Fig. 13: Critically undersized kitchen

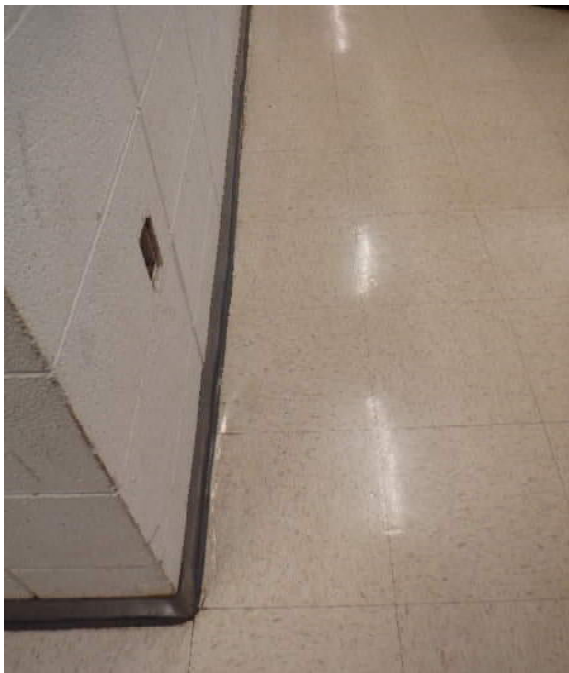
Fig. 2: Subsidence at upper level slab

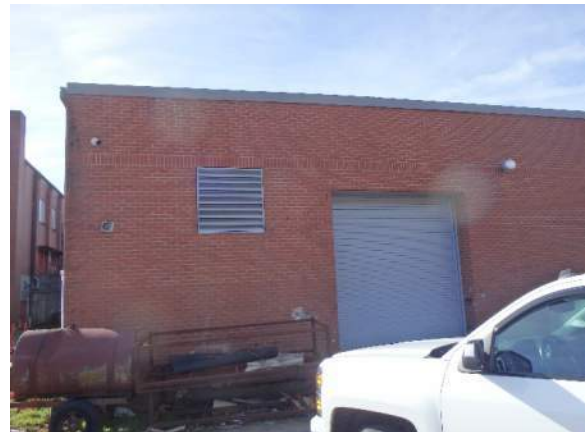
Fig. 4: Cracking at door & window heads.

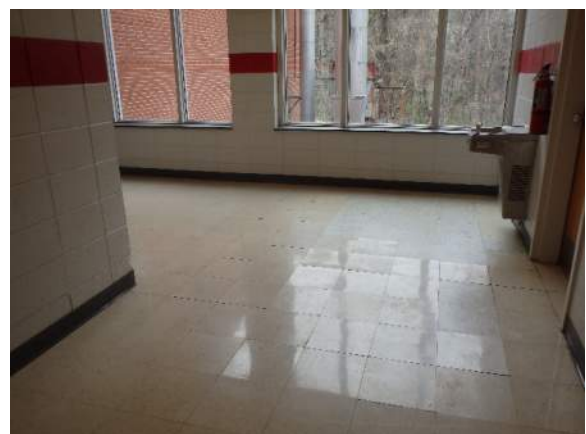
Fig. 5: Damaged VCT, upper level.

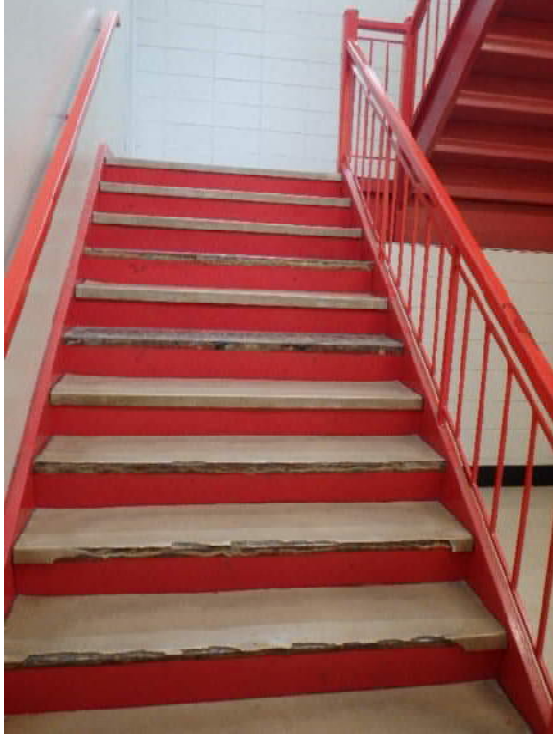
Fig. 6: Damaged flooring at stair.

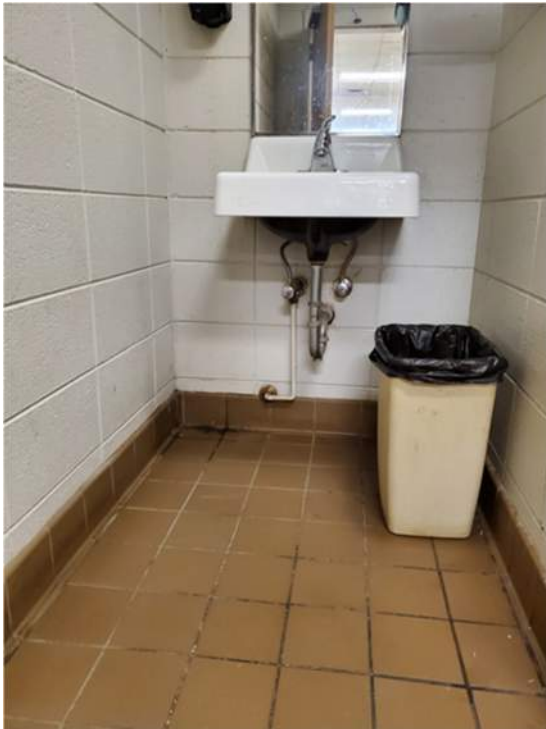
Fig. 7: Undersized restroom

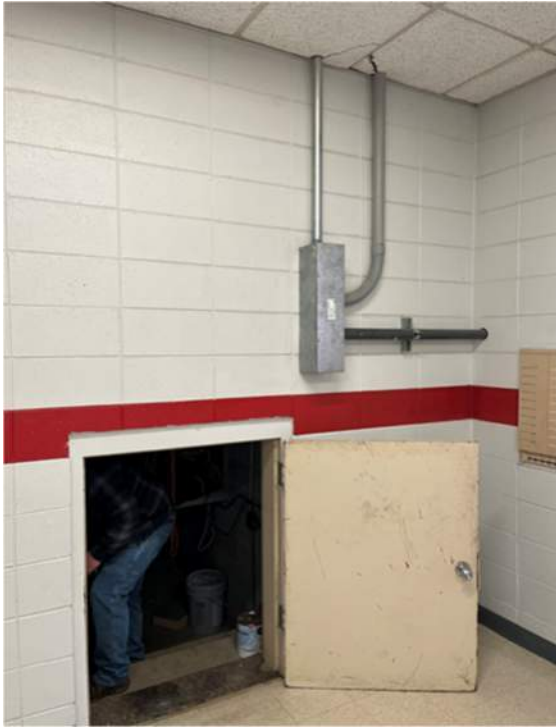
Fig. 14: Existing access restrictions

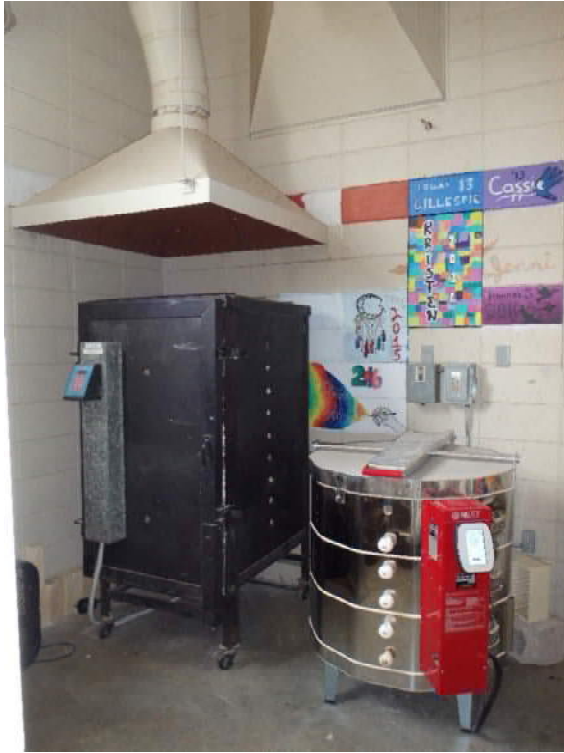
Fig. 19: Unenclosed kiln, unvented kiln.

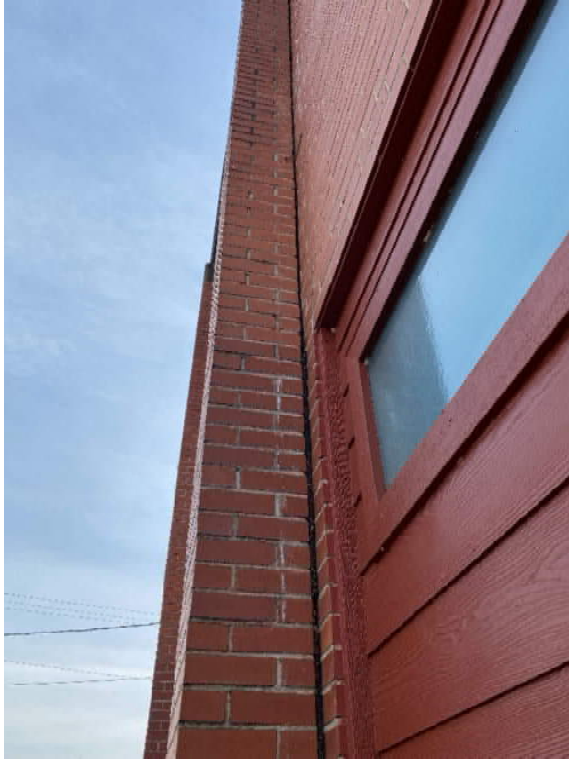
Fig. 1: Plumb bob showing extent of bowing at pilaster

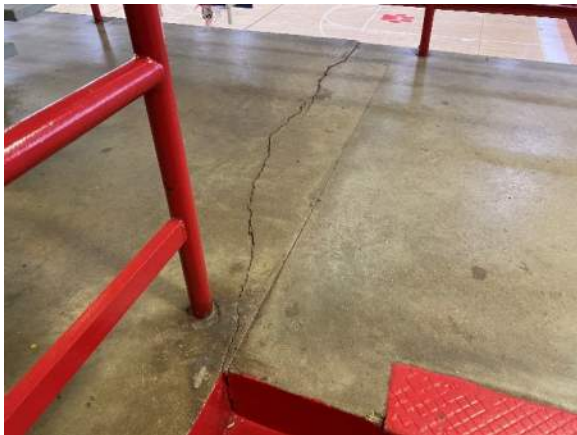
Fig. 2: Cracking at mezzanine slab

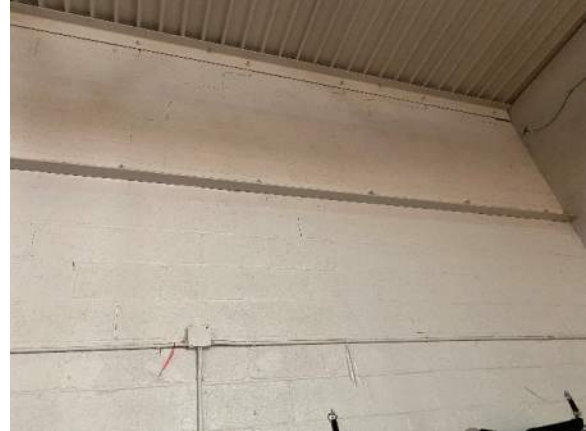
Fig. 3: Cracking at load-bearing CMU

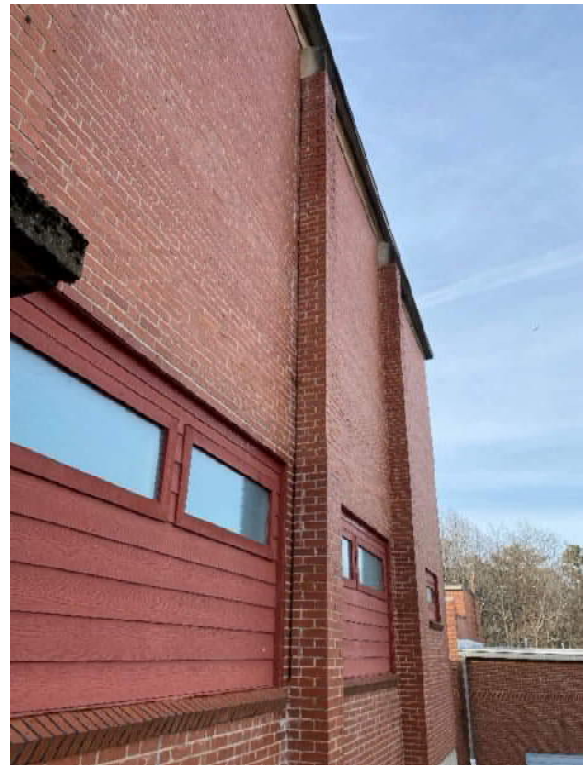
Fig. 4: Separation of pilasters from wall at control joints.

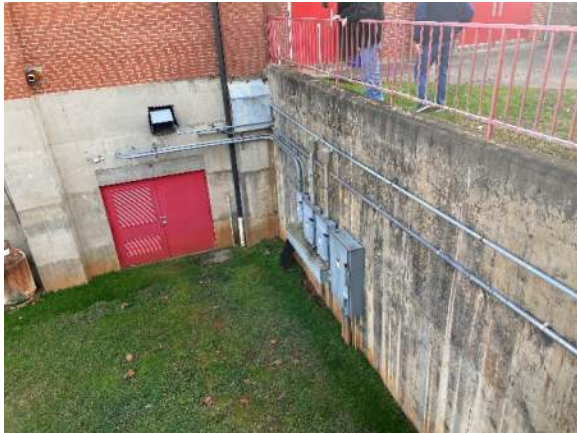
Fig. 5: Deteriorated retaining wall beside Gymnasium

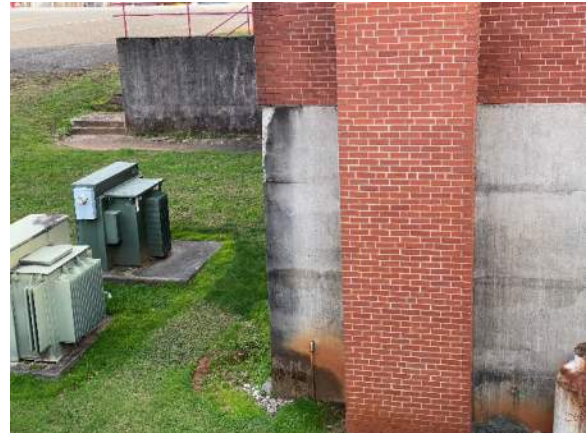
Fig. 7: Wall damage, lower level of Gymnasium.

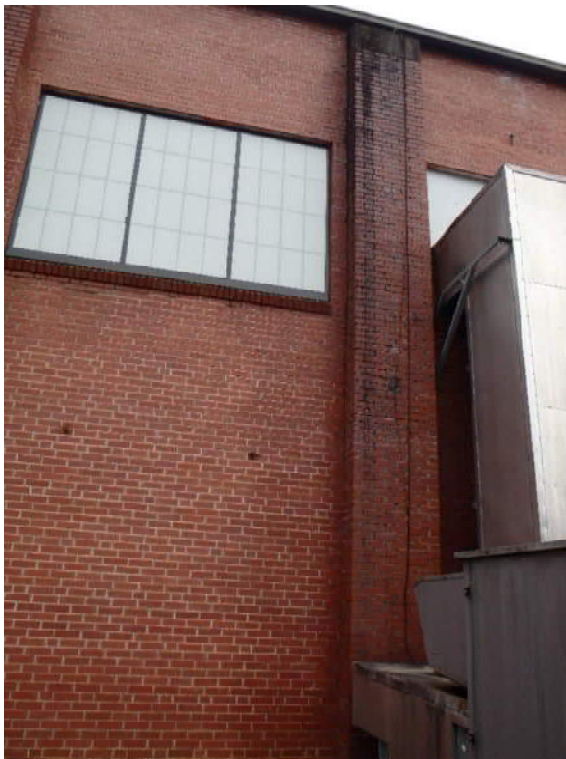
Fig 6: Extensive moisture penetration at mortar joints in walls, pilasters, sills.

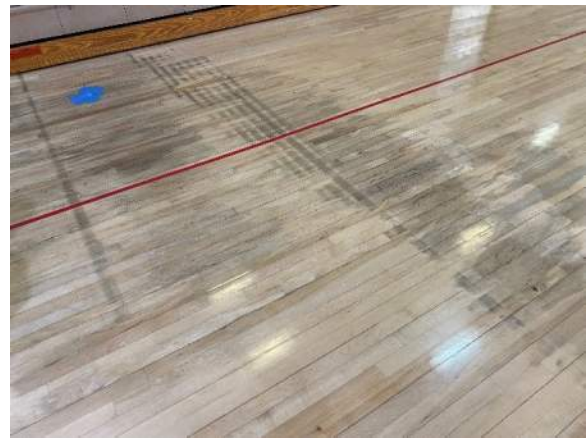
Fig. 8: Rotted gym flooring

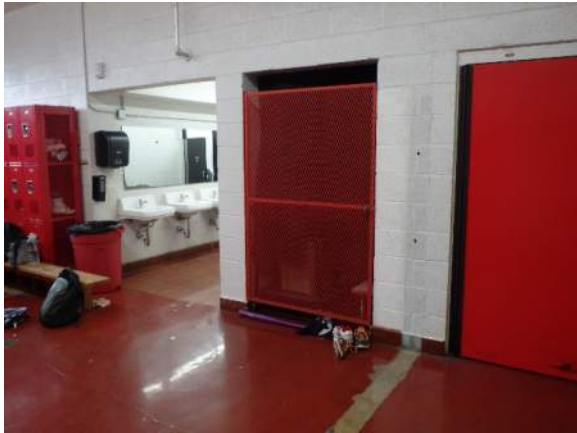
Fig. 10: Deteriorated flooring at locker room.
