FRANKLIN HIGH SCHOOL FACILITY ASSESSMENT

MACON COUNTY SCHOOLS

JUNE 2022

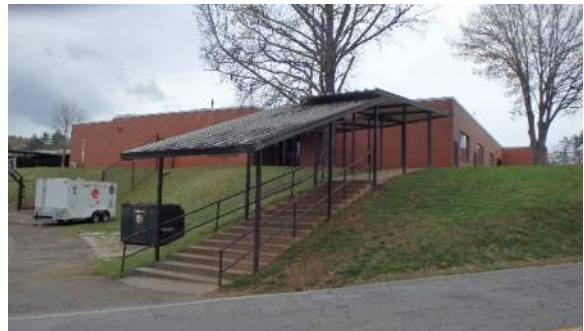
Fig. 4: Covered walk outside security fencing beside Media Center

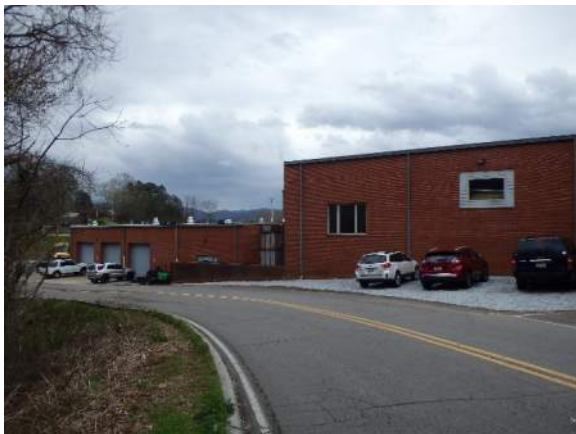
Fig. 2: Impromptu parking beside Vocational Building

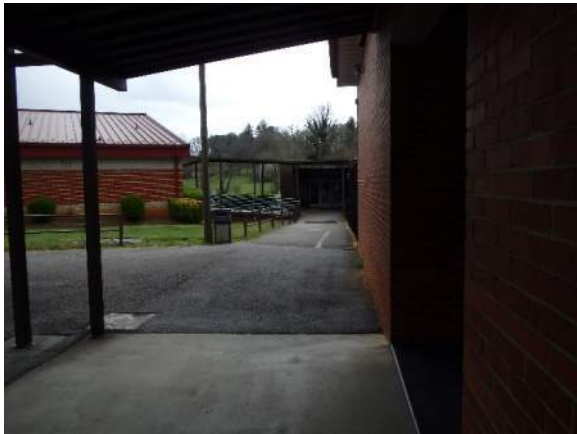
Figs 5 & 6: Walks, steps, ramps and rails:
Negotiating level changes at heart of campus

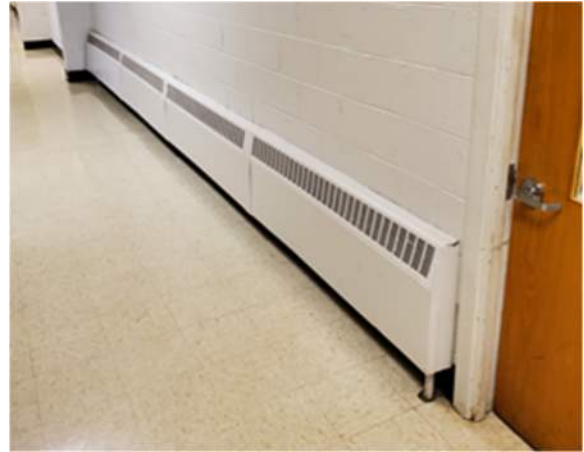
Fig. 6: Radiant heaters in hallways

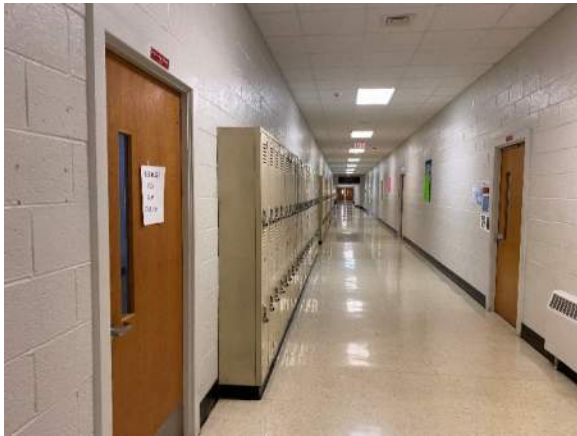
Fig. 4: Narrow corridors with 4" CMU walls

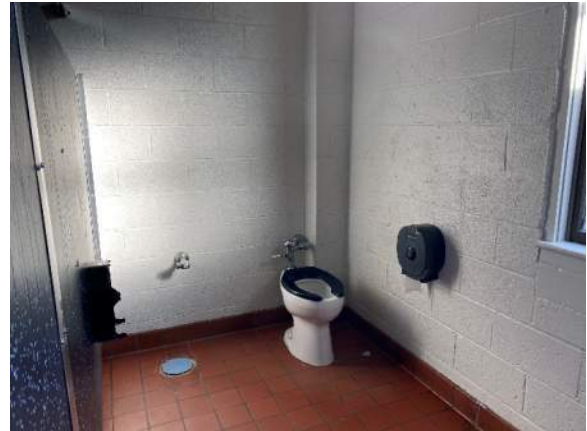
Fig. 15: Retrofit HC stall, no grab bars.

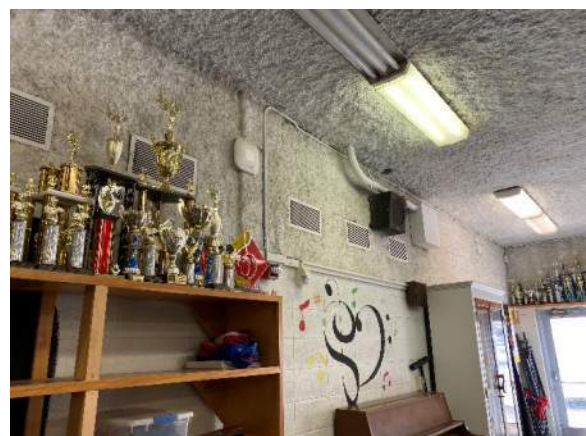
Fig. 6: Spray-on retrofit acoustical insulation

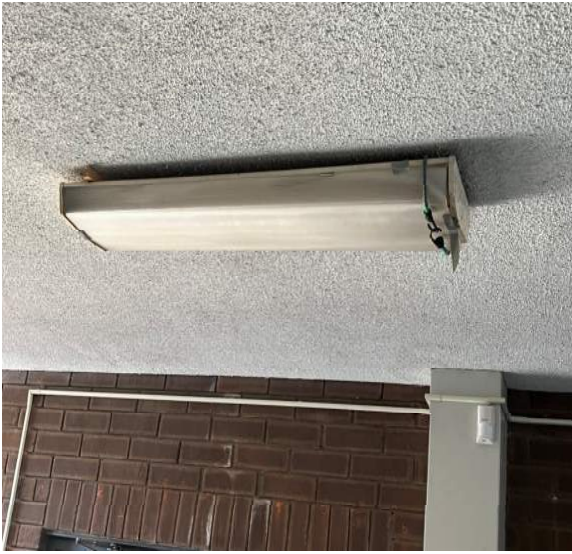
Fig. 15: Existing lobby light

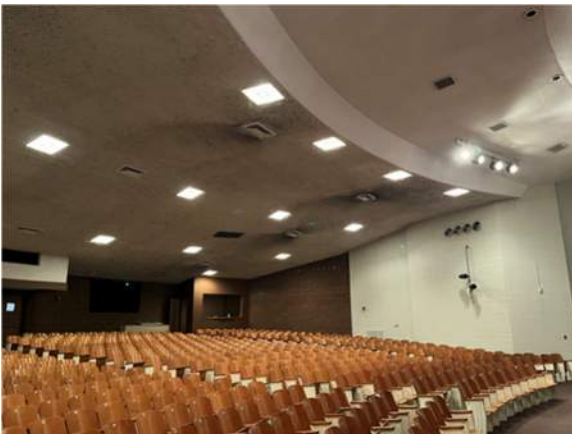
Fig. 16: Existing auditorium lighting

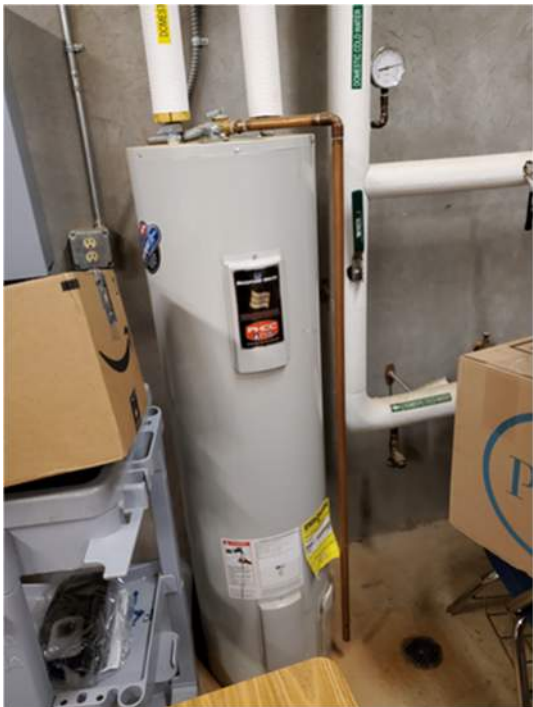
Fig. 6: Existing water heater

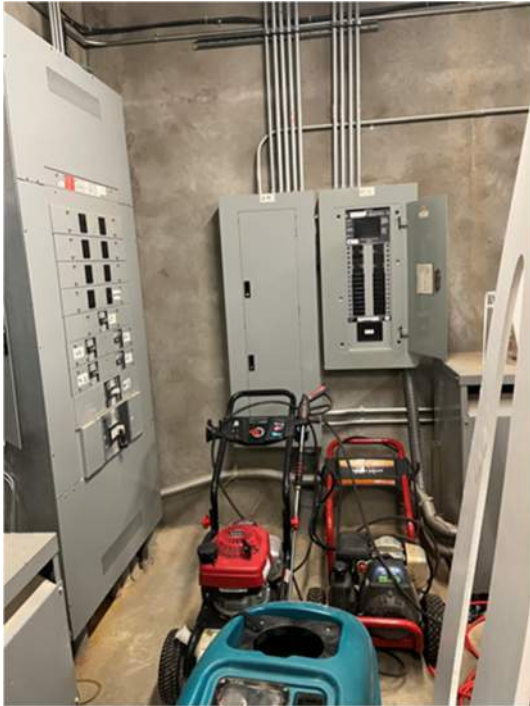
Fig. 9: Existing access to panels

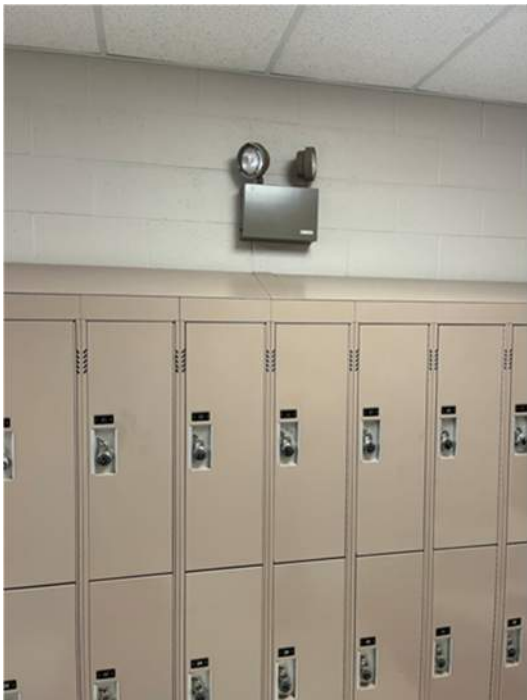
Fig. 10: Existing emergency light

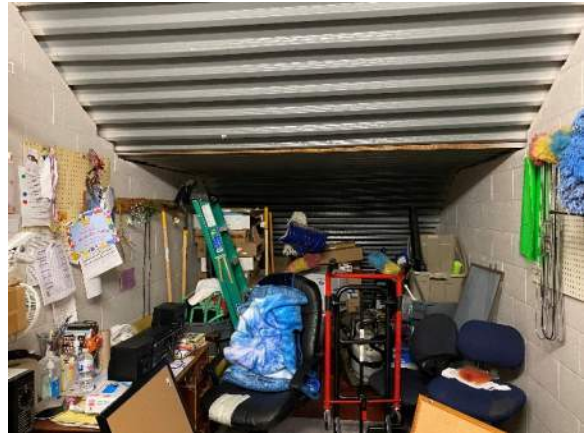
Fig. 11: Storage beneath unprotected breezeway stair.

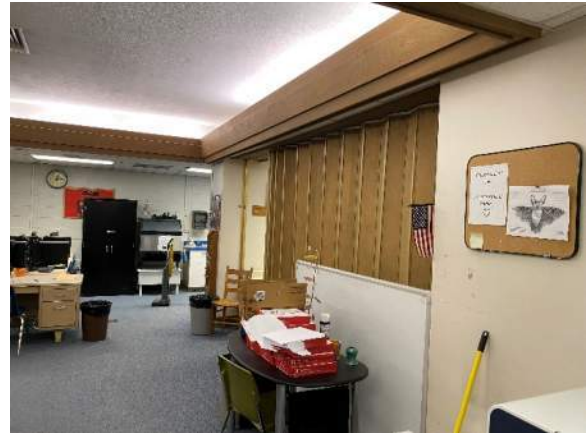
- Travel distances are acceptable per code; however, the lack of a contiguous through-building corridor at the upper level means some rooms do not have two choices of travel direction to an exit (see figure 15). Reconfiguration is required for code-compliant egress.

Fig. 15: Windowless space at core of upper floor

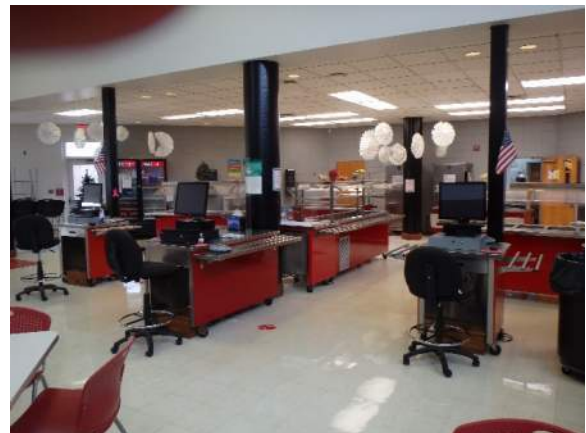
- The dining hall is dramatically undersized at 2,800 SF, and would require a 4,200 SF expansion to comply with NCDPI recommendations for a 1,200 student school (see figure 12).
- The kitchen is sized to serve a 600 student school; and should be nearly twice this size (see figure 13). The existing kitchen cannot be reconfigured or expanded without compromising service access.
- The serving area is approximately 20% too small to accommodate 1,200 students (see figure 14). Staff cannot refill serving tables without passing through lines of students.

Fig. 14: Undersized serving area, staff pass through students to refill serving tables.

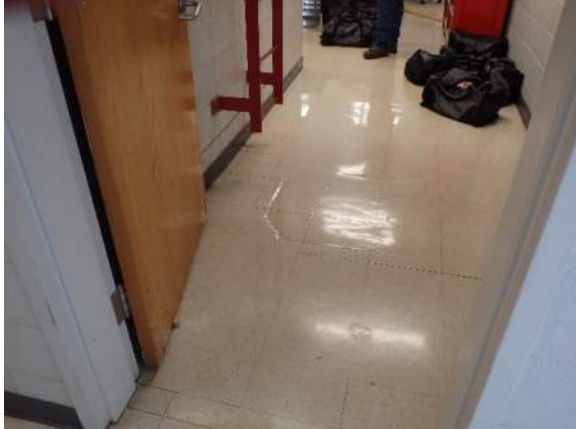
Fig. 1: Subsidence at upper level slab

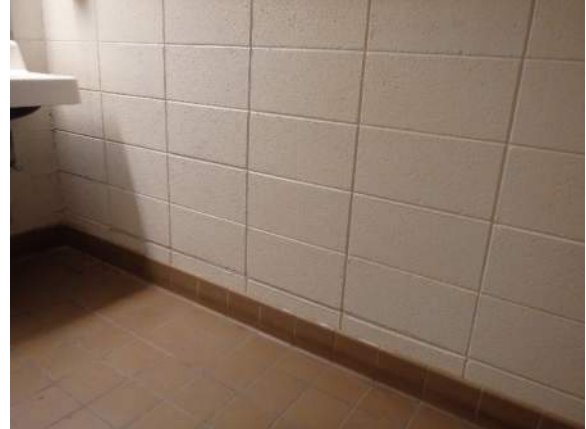
Fig. 3: Subsidence at upper level slab

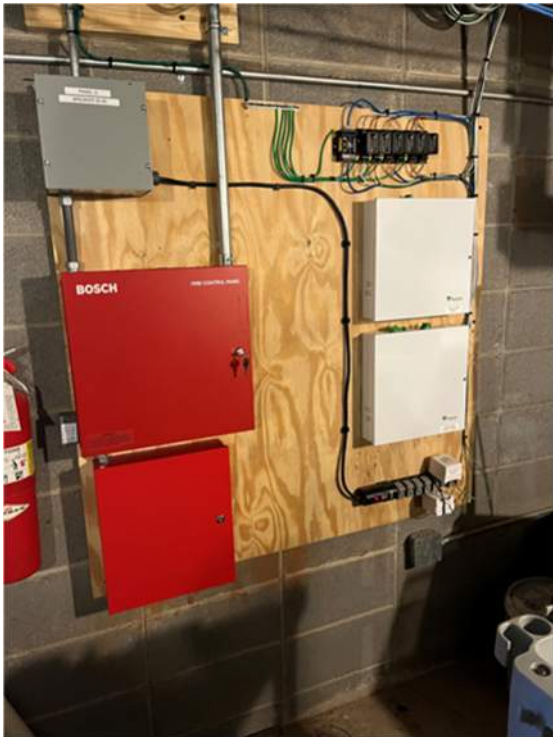
- The original power and communications service is inadequate for current usage. Access to the existing building communications and fire alarm equipment is restricted (see figures 14 and 15).

Fig. 15: Existing communications & fire alarm

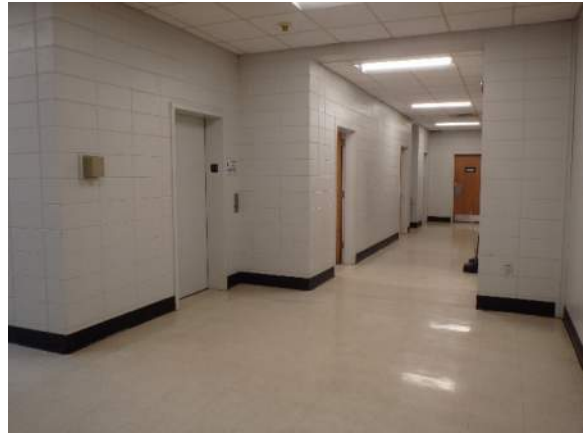
- The upper level corridor constitutes a dead end in excess of 50 feet long which is never permissible, even in a sprinklered building (see figure 16). Reconfiguration of the upper level corridor is required.

Fig. 16: Upper level dead end corridor

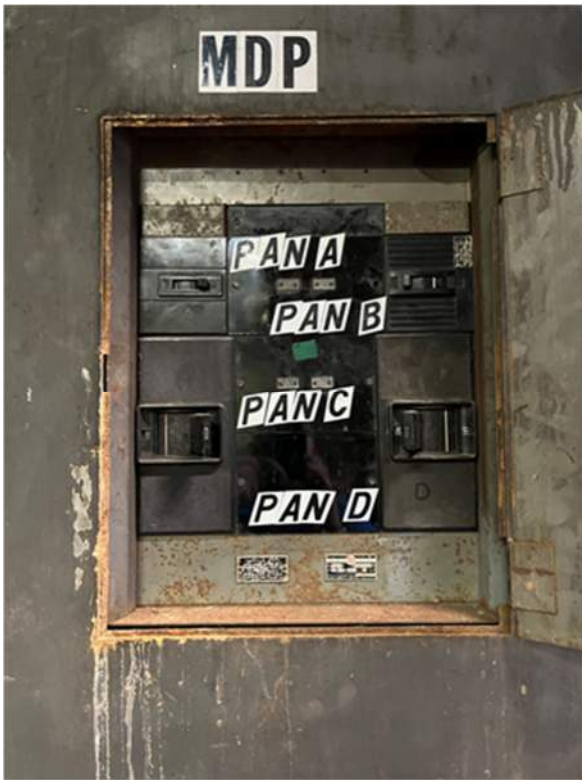
- Most of the power service is original to the building and requires replacement and upgrades. The original power service to the building is a Trumbull Electric 400A - 208Y/120V panelboard (see figure 14 and 15). Parts/breakers are no longer available, is in very poor condition. Some of the existing panels are in very poor condition and should be replaced. In addition, the overall power available maybe inadequate to a modern educational program. An overall load analysis would need to be performed to determine any available capacity in this system for potential renovation. During most renovation projects a new service and electrical distribution throughout would need to be provided.

Fig. 15: Existing main panel

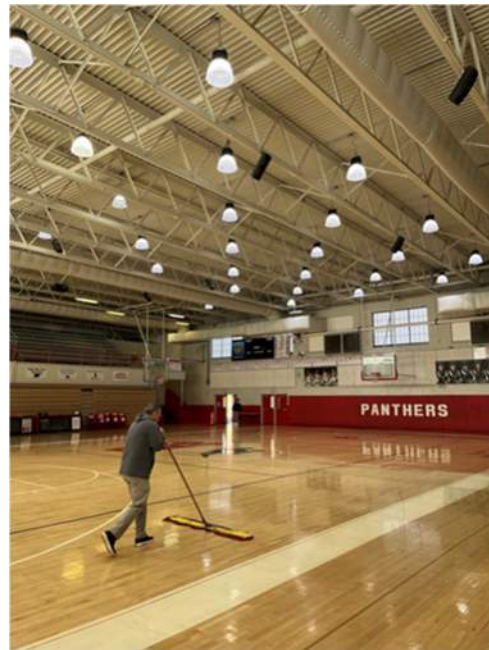
- No emergency power is provided to this building.
- General lighting throughout the building is fluorescent fixtures and mostly in poor working condition and in need of replacement. Fluorescent lamps are still available today, but it is recommended to replace all of these fixtures with new, high performance LED fixtures. The gym lighting was replaced in recent years (see figure 17).

Fig. 17: Existing gym lighting

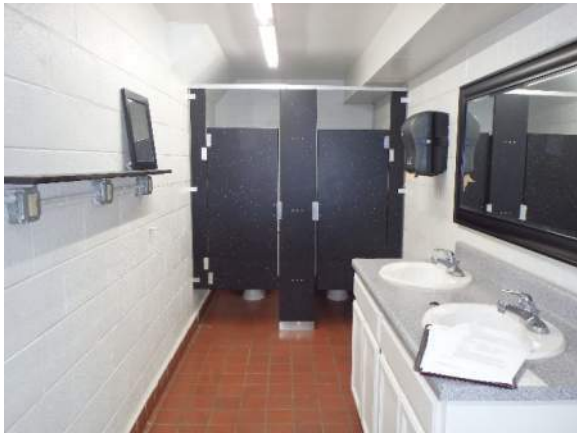
- Group bathrooms in the locker rooms are not accessible and too small to be reconfigured for accessibility (see figure 19). Relocation of bathrooms to an addition should be considered.
- Curbs at shower rooms make them inaccessible (see figure 20).
- Bleachers do not meet ADA requirements. Replacement bleachers are needed.

Fig. 19: Non-accessible bathrooms in locker room.

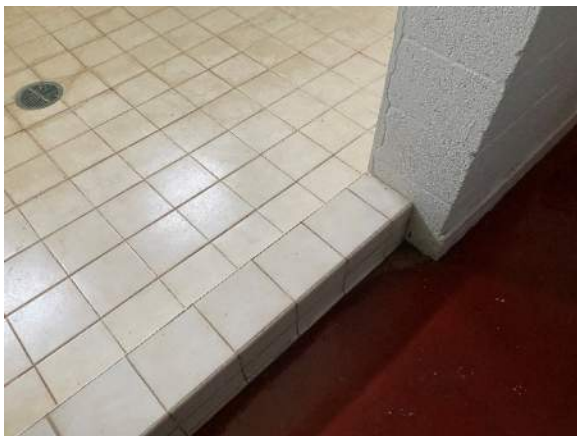
Fig. 20: Curb at shower room
