FRANKLIN HIGH SCHOOL FACILITY ASSESSMENT

MACON COUNTY SCHOOLS

JUNE 2022

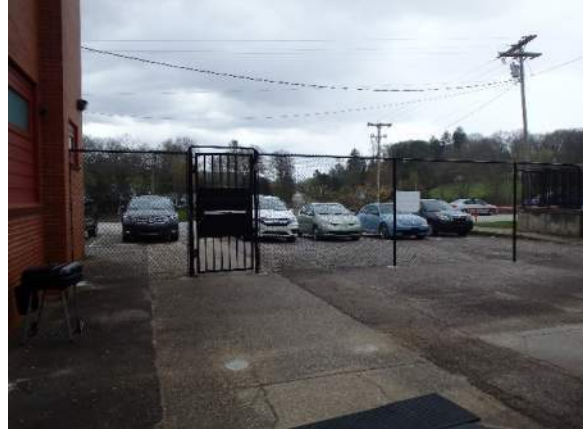
Fig. 3: Perimeter security fence

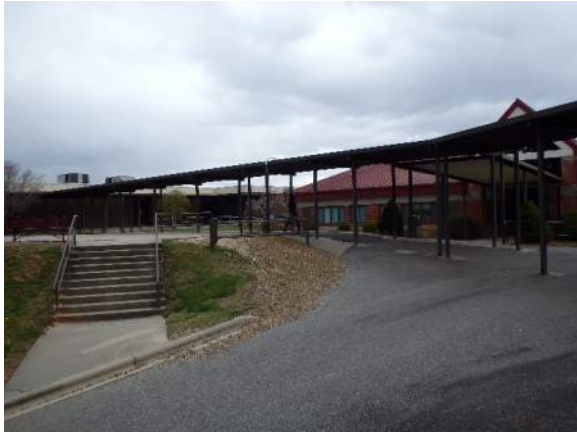
Figs 5 & 6: Walks, steps, ramps and rails:
Negotiating level changes at heart of campus

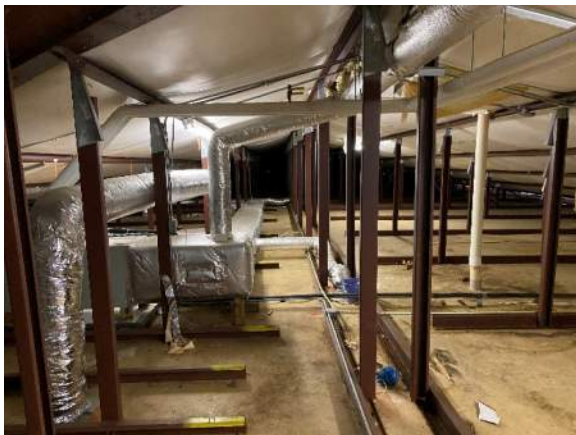
Fig. 1: Overbuild roof system, Main Building

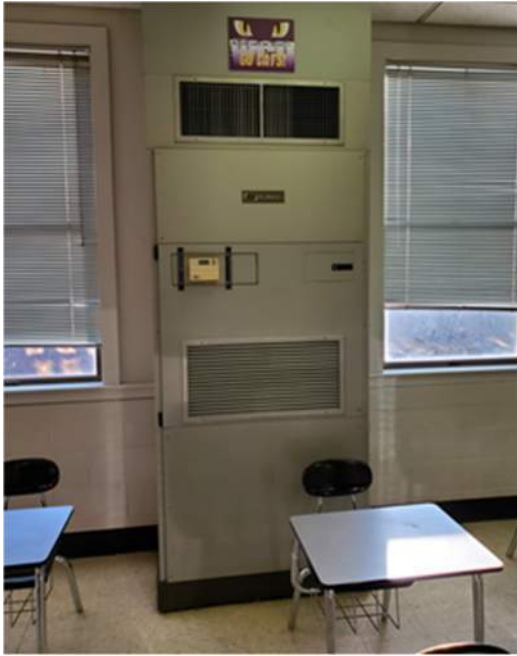
Fig. 8: Bard unit

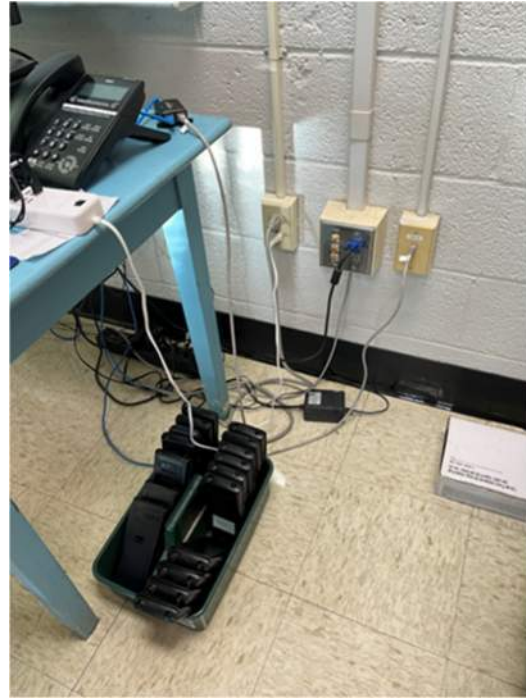
Fig. 10: Insufficient Receptacles

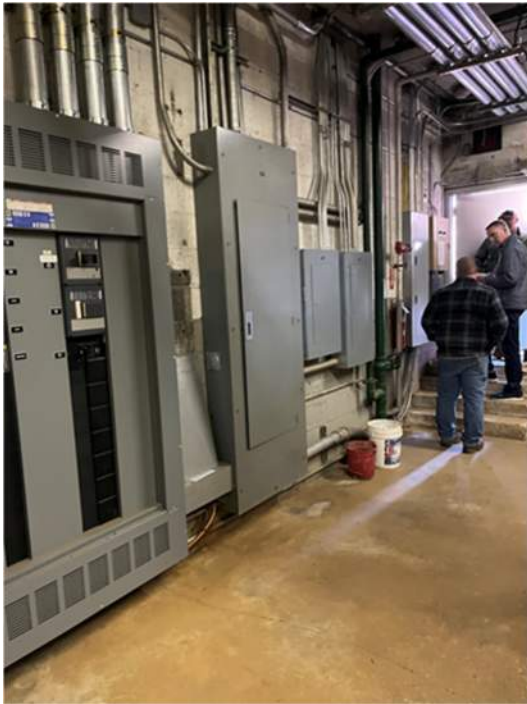
Fig. 9: Existing Service

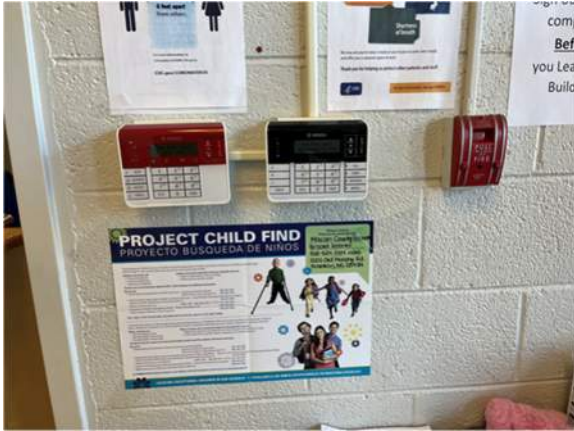
Fig. 12: Manual pull station

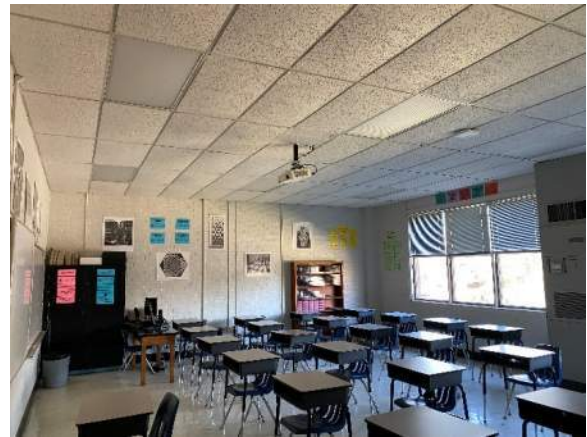
Fig. 16: Typical classroom

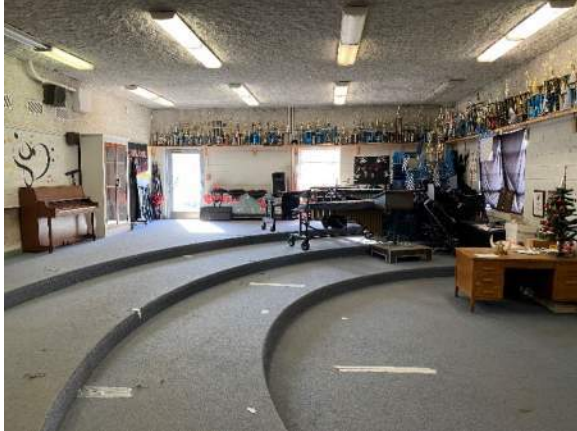
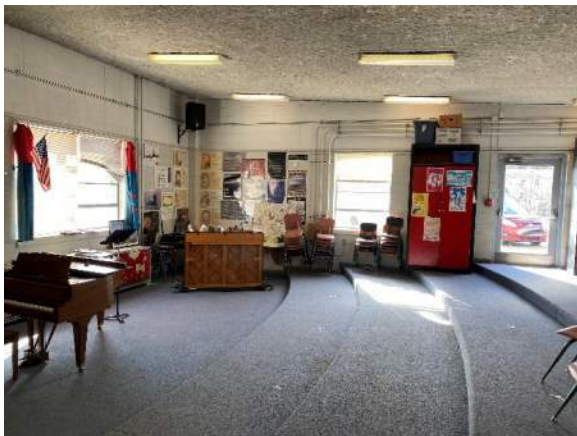
Figs 1 & 2: Tiered band and chorus rooms

- Enlargement of the auditorium is not a viable option given the close proximity of adjacent structures.
- The auditorium floor can potentially be overbuilt with steel studs, metal deck and a lightweight concrete slab, to level it out. Band and Drama/Dance can relocate to the upper floor.
- The tiered band room can be leveled for accessibility and chorus relocated to that area. Acoustics will be acceptable, not optimal.
- A small addition could provide a safer enclosed exit stair, elevator and upper level bathrooms. Alternately, program space could be sacrificed to develop these facilities within the existing footprint.

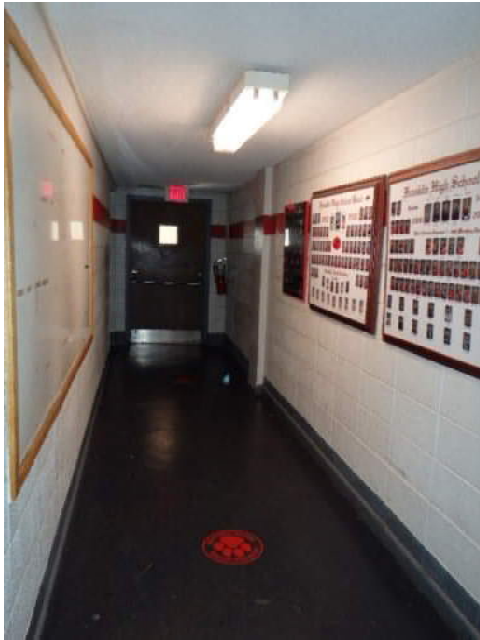
Fig. 7: Narrow corridor, low headroom

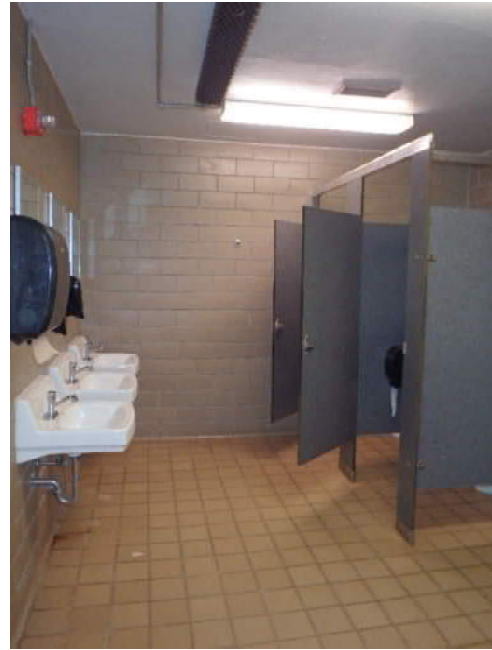
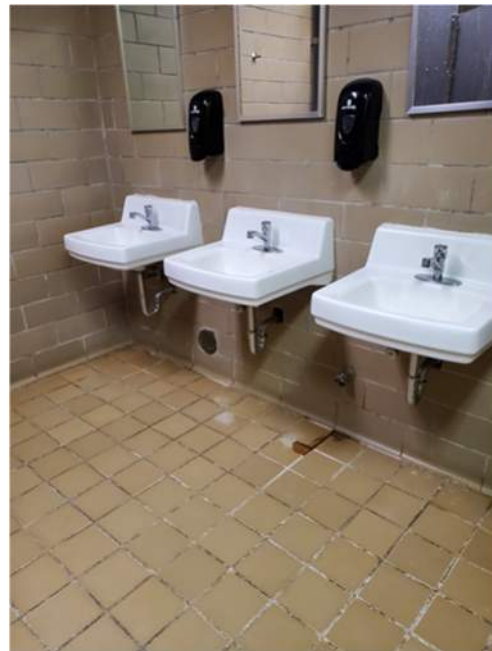
Figs 9 & 10: Lower level bathrooms

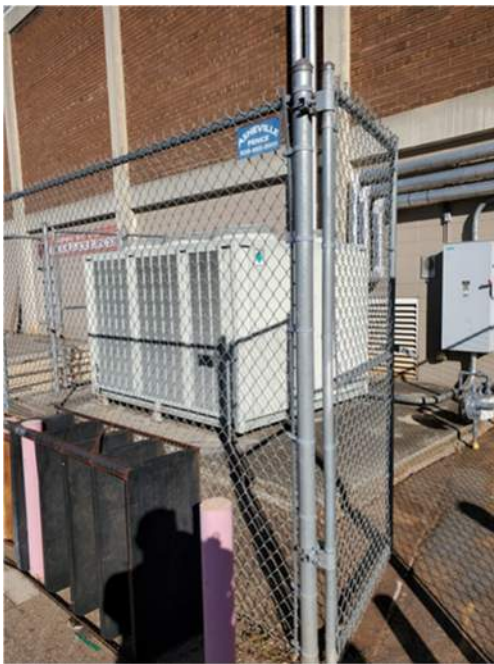
Fig. 8: Chiller

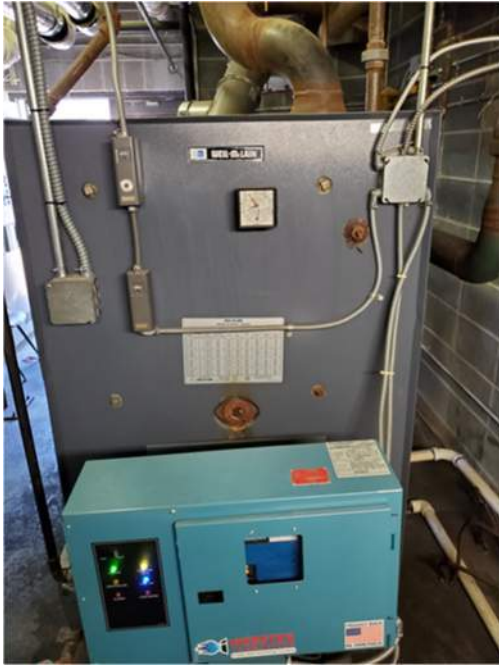
Fig 11: Boiler

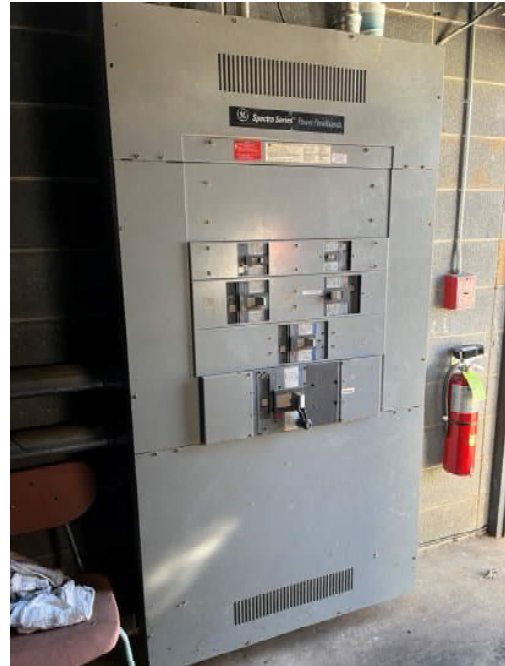
Fig. 13: Existing service

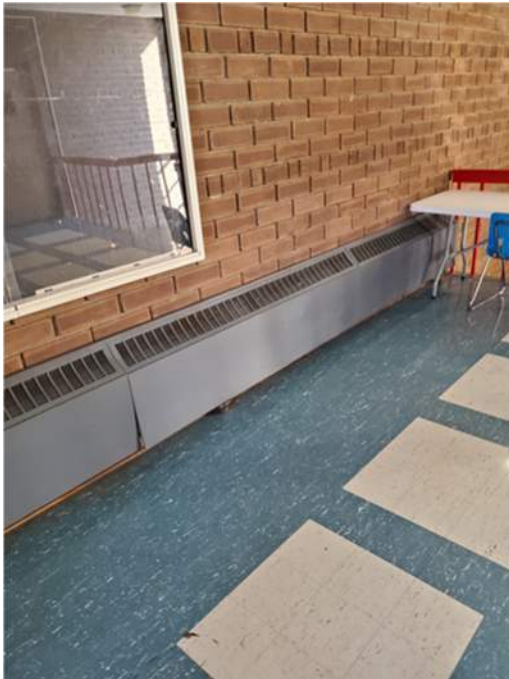
Fig. 12: Radiant heaters

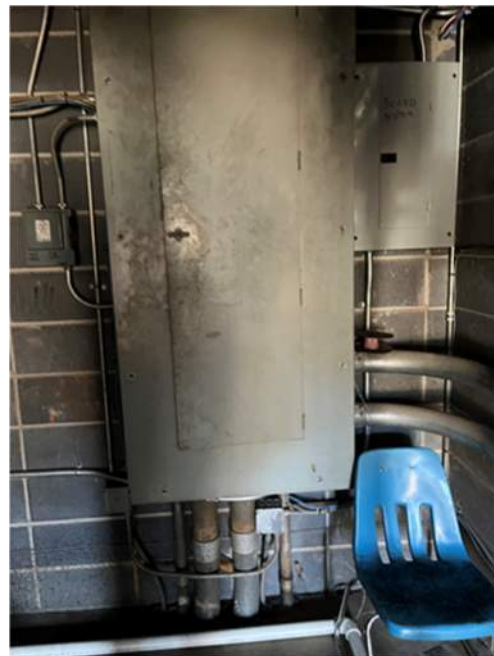
Fig. 14: Existing panel

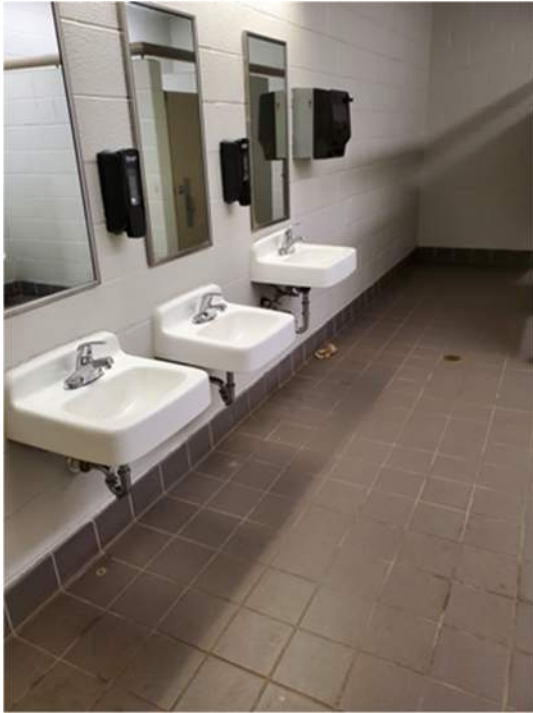
Fig.5: Group restroom

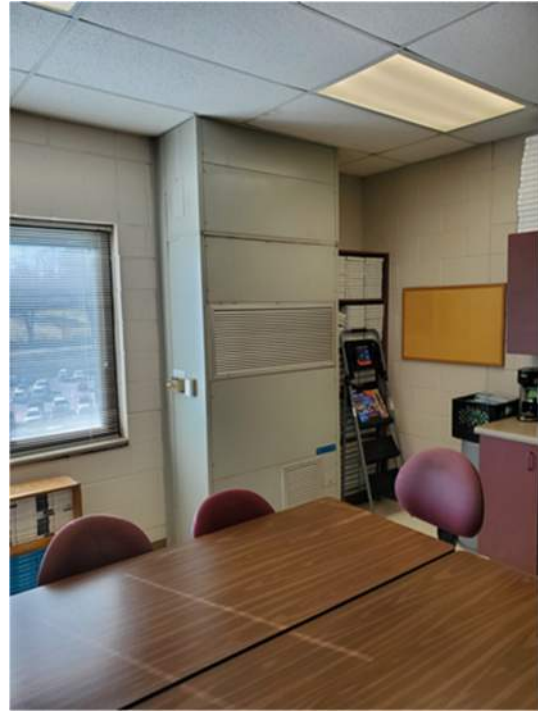
Fig. 7: Classroom AHU

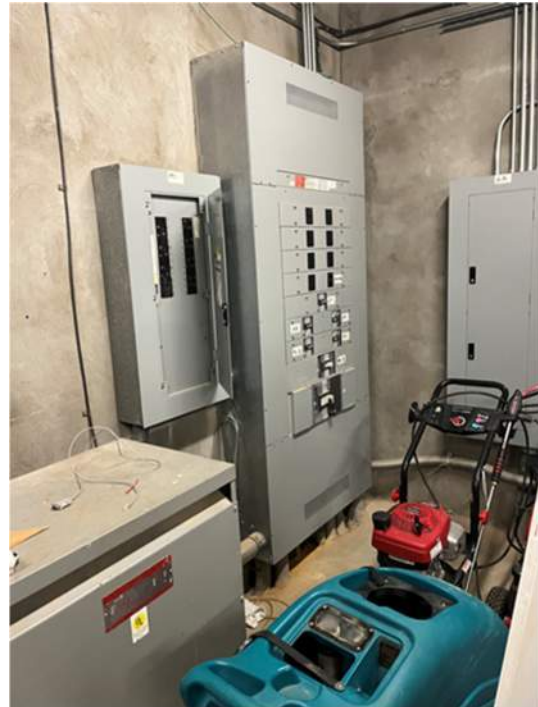
Fig. 8: Existing service

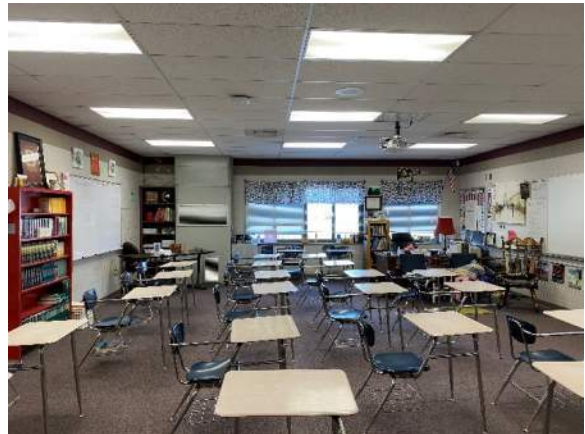
Fig. 12: Typical classroom

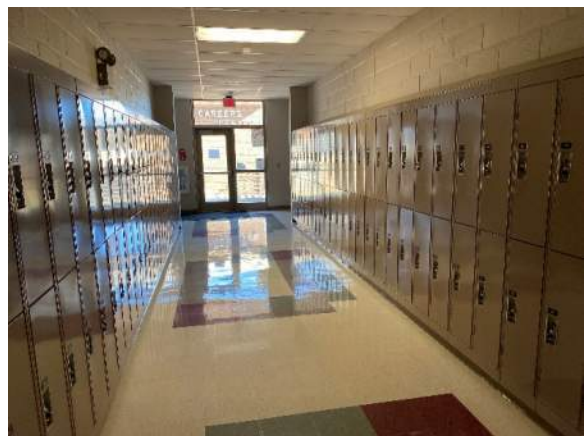
Fig. 13: Corridor

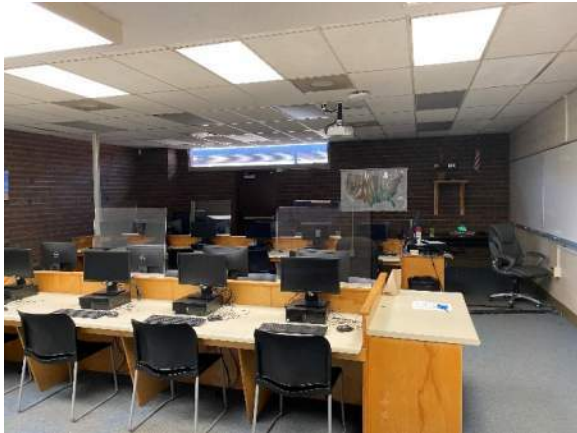
Fig. 13: Business lab, high windows

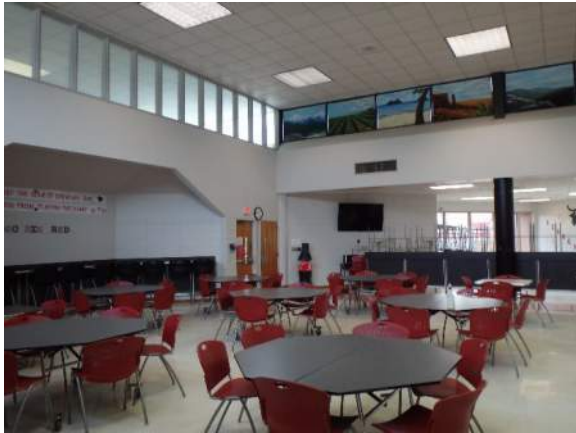
- The dining hall is dramatically undersized at 2,800 SF, and would require a 4,200 SF expansion to comply with NCDPI recommendations for a 1,200 student school (see figure 12).
- The kitchen is sized to serve a 600 student school; and should be nearly twice this size (see figure 13). The existing kitchen cannot be reconfigured or expanded without compromising service access.
- The serving area is approximately 20% too small to accommodate 1,200 students (see figure 14). Staff cannot refill serving tables without passing through lines of students.

Fig. 12: Tiny dining room.

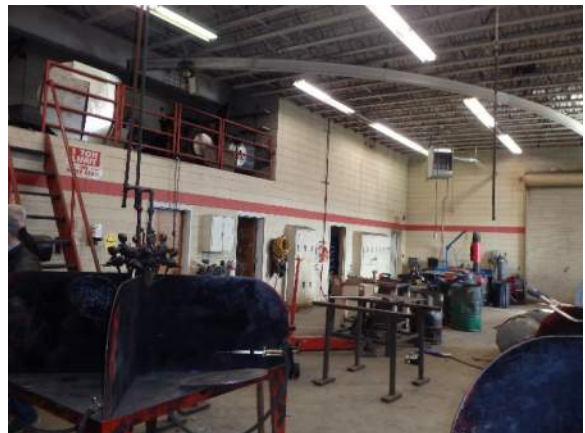
- There is an elevator for accessible floor-to-floor travel.
- Mezzanines at shop areas are not required to be accessible, but it is difficult to access these areas (see figure 18).
- Many doors lack accessible lever hardware. Replace hardware as required.
- Student and staff bathrooms are not ADA compliant and are too small to be renovated for compliance (see figure 7). Enlarge or supplement bathrooms as required to provide accessible restrooms at each floor.

Fig. 18: Mezzanine railings.

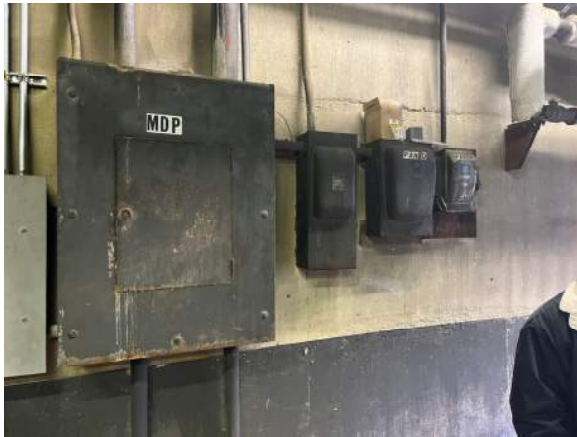
- Most of the power service is original to the building and requires replacement and upgrades. The original power service to the building is a Trumbull Electric 400A - 208Y/120V panelboard (see figure 14 and 15). Parts/breakers are no longer available, is in very poor condition. Some of the existing panels are in very poor condition and should be replaced. In addition, the overall power available maybe inadequate to a modern educational program. An overall load analysis would need to be performed to determine any available capacity in this system for potential renovation. During most renovation projects a new service and electrical distribution throughout would need to be provided.

Fig. 14: Existing service

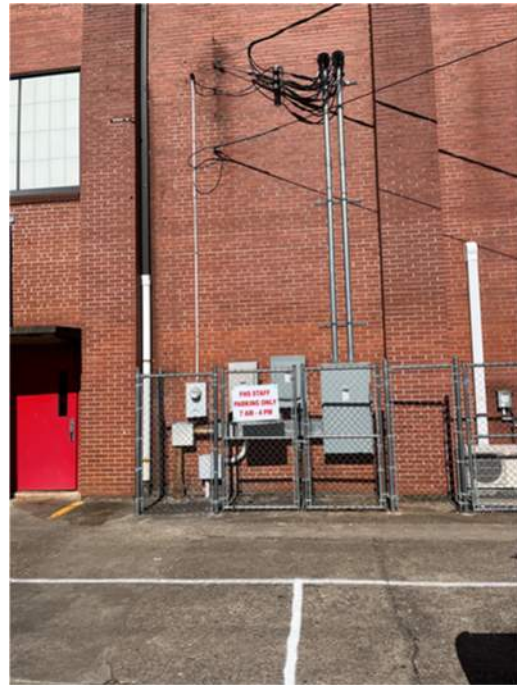
- Some electrical panels are in non-secure spaces.
- A new electrical service was provided to the facility 600A -208Y/120V, back feeding to the original electrical equipment (see figure 16)

Fig 16: Existing new service

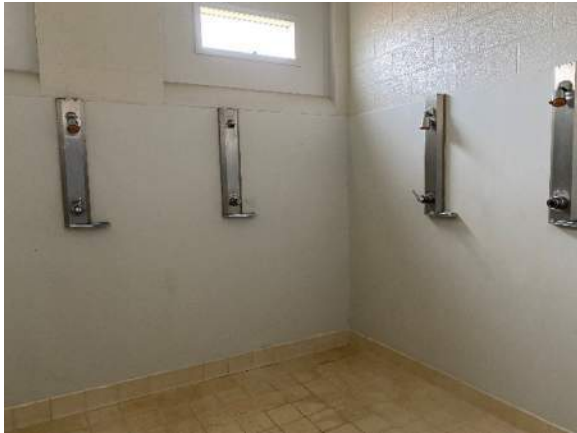
- The bathroom fixture count is inadequate to meet current code requirements. Additional bathrooms are required; an addition to the building would be advisable.
- Health regulations no longer permit open showers without stalls (see figure 18).

Fig. 18: Shower room, no stalls
